Technical Report ARAEW-MR-06017

Analysis of Ta/Ni Multilayer Cold Spray Coatings

September 2006

ARMAMENT RESEARCH, DEVELOPMENT AND ENGINEERING CENTER
Armaments Engineering & Technology Center
Weapon Systems & Technology

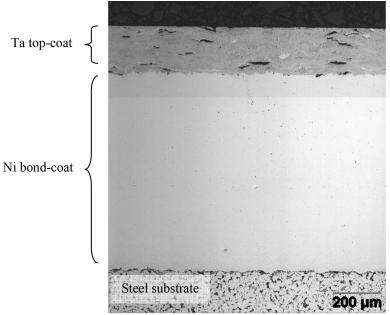
Ta coating thickness was uniform across the small sample at $210\pm15~\mu m$. The Ni bond coat thickness was also uniform but much thicker at $820\pm20~\mu m$ as indicated in Figure 1.

Figure 1. Cross-section of ARL cold spray specimen illustrating thickness variation.

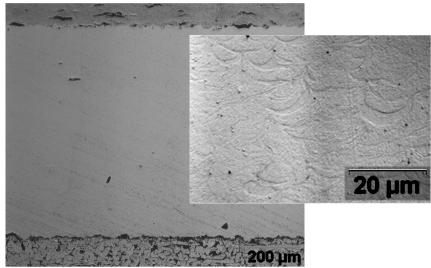
The Ni bond-coat is dense as illustrated in Figure 3. The cold spray technique leads to a scalloped work-hardened structure as illustrated in the inset image. The microhardness of the Ni is substantially harder than the underlying substrate at \sim HK₅₀ 450-500.

Figure 3. Cross-section of Ni bond-coat and at high magnification (inset).

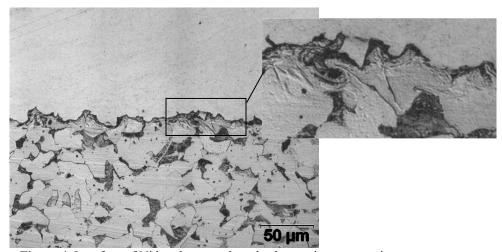
The interface between the Ni bond-coat and the steel substrate is illustrated in Figure 4. The impact of the high velocity Ni particles results in severe plastic deformation of the soft steel as illustrated by the image inset. The structure of the interface is similar to that of a friction or explosive weld. The dense, irregular interface in the absence of porosity as shown here should result in excellent adhesion of the Ni to the substrate. The bombardment of Ni particles and the subsequent "stirring" of the steel should also assist in breaking up any oxides that might otherwise hinder adhesion. One issue that must be considered is whether this level of deformation would occur on a harder martensitic gun steel structure. It is difficult to predict what the morphology of the interface would be in this case.

Figure 4. Interface of Ni bond-coat and steel substrate in cross-section.

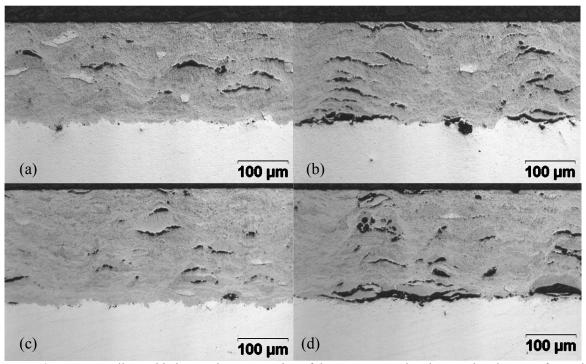
The structure of the Ta top-coat is less dense than the Ni bond-coat as illustrated in Figure 5. There is substantial variation in the porosity, which tends to run normal to the impingement

direction of the Ta particles. The increased porosity is most likely due to two factors. Those being, Ta is substantially denser than Ni (16.65 g/cm³ vs. 8.91 g/cm³) and has a much higher melting point (2996°C vs. 1455°C). The orientation of the porosity is of concern as it may result in lamellar failure where large portions of the coating may spall during a wear event. Additionally, in many areas, there is porosity directly along the interface of the Ta and Ni. This may result in premature adhesive failure.

Figure 5. Metallographic images in cross section of the Ta top-coat showing varying degrees of porosity. Images (a) and (b) are longitudinal cross-sections, while (c) and (d) are transverse.

- The Ni bond-coat cladding is much denser than the Ta top-coat most likely due to the differences in density, melting point, and crystal structure (FCC Ni vs. BCC Ta). Perhaps modifying parameters such as particle velocity and temperature may alleviate these effects.

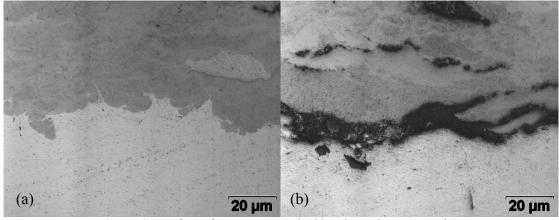
Figure 6 illustrates the Ta-Ni interface at high magnification. As illustrated in Figure 6 (a), where porosity is not present the interface exhibits good intermixing of the Ta and Ni. Figure 6 (b) illustrates the porosity that can occur and in this case some foreign debris that may have impeded bonding.

Figure 6. Interface of Ta top-coat and Ni bond-coat in cross-section. (a) dense interface (b) porous interface.

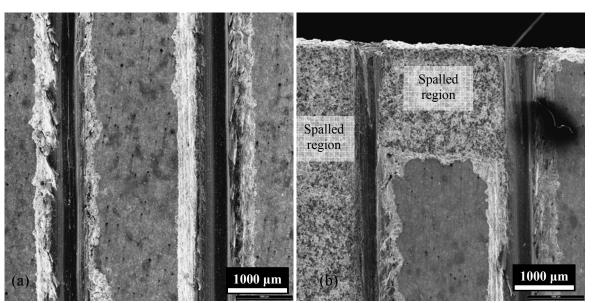
Given below are SEM images of the sample subjected to groove testing. Figure 10 (a) illustrates an area where the coating remained generally intact with only small areas of cohesive failure while Figure 10 (b) is near the unsupported edge of the sample where large areas have failed at the Ta-Ni interface on both the left side of the groove and in between the grooves.

Figure 10. SEM images of the surface of the sample subjected to groove adhesion testing where (a) the coating remained primarily intact and (b) the coating failed catastrophically.

- The hardness of the Ta is much higher than bulk or work-hardened Ta indicating the possible incorporation of impurities or an alloying effect with the co-deposited Ni.
- Catastrophic failures during groove adhesion testing give evidence that the transient thermal stresses generated during gun firing would act to spall the porous Ta coating.

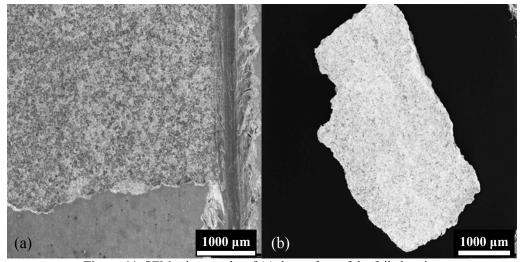
Figure 11. SEM micrographs of (a) the surface of the failed region and (b) the underside of the recovered chip.

A chip was recovered from one of the spalled regions. Both the surface of the spalled region and the mating surface on the underside of the recovered chip were analyzed via EDS to determine the exact nature of the failure.

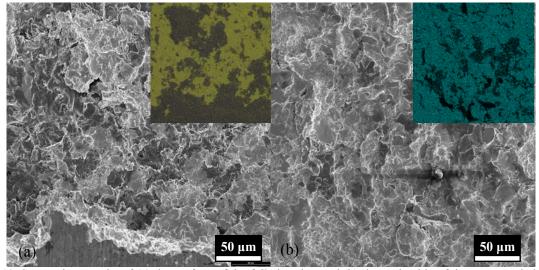
EDS was used to determine whether the failure was primarily adhesive (interface) or cohesive (within coating or substrate). Figure 12 shows high magnification images of the surface and underside of the chip. Inset are EDS maps of the images showing composition. For Figure 12 (a), the yellow indicates Ni while the dark areas indicate Ta. For Figure 12 (b) the blue indicates Ta while the dark areas indicate Ni. Based on the mixture of Ta and Ni on both areas, it can be inferred that failure most likely originated within regions where the interface was porous and continued to fracture cohesively through the two materials where they are well bonded. A greater percentage of Ta is present on the Ni substrate than Ni on the Ta chip, indicating that cohesive fracture occurred primarily through the Ta. This is not surprising since the Ta was demonstrably more porous based on metallographic analysis, which would yield a lower fracture strength.

Figure 12. SEM micrographs of (a) the surface of the failed region and (b) the underside of the recovered chip. Inset are the EDS maps of the same.

- The Ni-steel interface was much denser than and contiguous than that of the Ta-Ni. This is due not only to the issues mentioned above but also to the fact that the Ni makes for a harder, more impact resistant substrate than the underlying steel. The porosity of the Ta-Ni interface resulted in failure during groove adhesion testing.

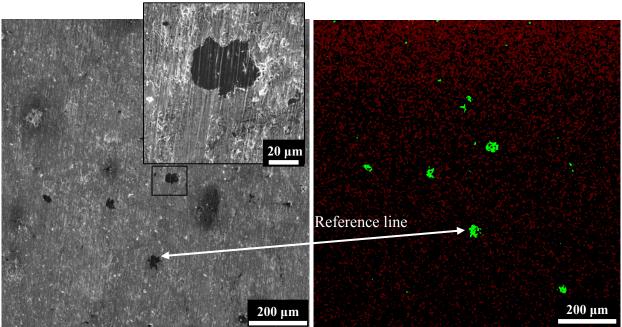
In addition to the EDS analysis of the areas subjected to groove adhesion testing. The asdeposited surface was also analyzed to verify the composition of the inclusions observed in cross-section. The grinding marks are clear on the surface of the Ta and Ni inclusions which give a good contrast between the two materials as illustrated inset in Figure 13. The red in the EDS map of the image given in Figure 13 (b) indicates Ta while the green indicates Ni. As expected, the inclusions within the coating are indeed Ni.

Figure 13. (a) SEM micrograph of the surface of the as-deposited cold spray coating and (b) an EDS map of the same region illustrating presence of Ni inclusions.

- The structure of the Ni bond-coat is more homogenous than that of the Ta. The Ta actually contains large interspersed zones of Ni possibly due to Ni contamination within the cold spray nozzle.
